PREVENTION OF FAILURE TO GIVE A GUARANTEE CONSTRUCTION OF BORED PILES FOUNDATION AT LEMAH IRENG BRIDGE, SEMARANG – SOLO TOLL ROAD, INDONESIA

EDY PURWANTO

Department of Civil Engineering , Faculty of Civil Engineering and Planning, Islamic University of Indonesia,
Yogyakarta, Indonesia

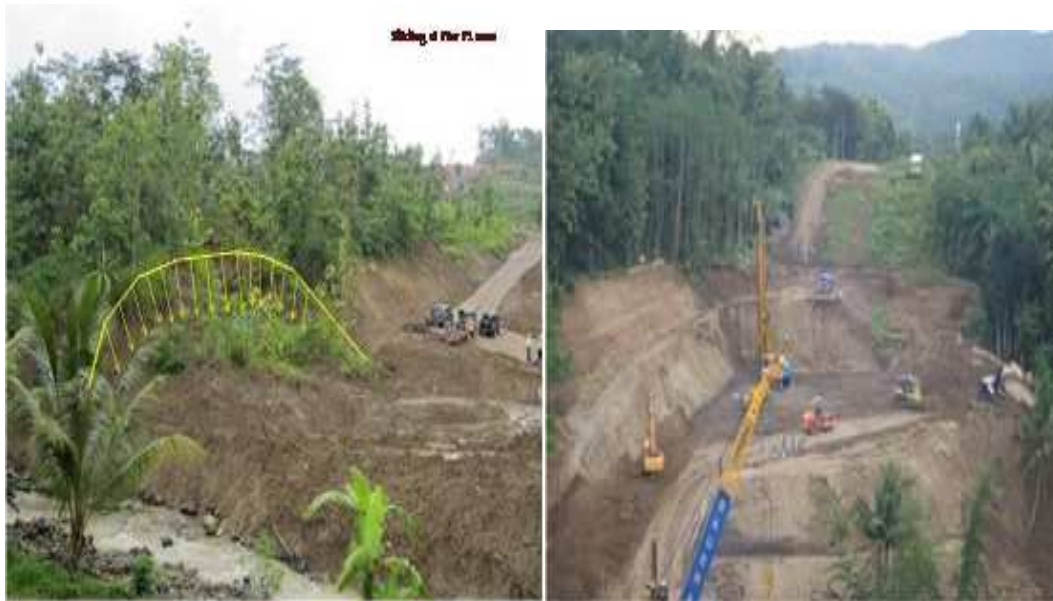
Figure 2: Slope Failure Located at Above Pier P-1 Sta. 22+625

The slip failure occurred on the natural slope above Pier P-1 when the plat-form of Pier P-1 was constructed. This failure caused by rain-fall infiltre enter the clay shale and it cause decline the shear strength of soil and be side that, the soil work was realised in rain season,

Slope collapse occurred is located on top of Pier P-1 includes a fairly wide area and a large land mass, so that it feared would disturb the implementation of the foundation work and influence the bored pile foundation stability Pier P-1 that lies beneath (see Figure 2)

The author side, the condition in the field indicate that the ground moves downwards make a slit width of 1.00 meters along the northern slope. A sliding slope forms a gap and is accompanied by get out water significantly from the gap. It indicates that the landslide which occurred caused by a rain water infiltrates into the ground and caused by a soil cutting on the foot of the slope. The sliding slope include a fairly wide area and the movement of soil is predicted will push the bored pile Pier P-1.

Results of the investigation in the field indiqute that the slope failure was identified caused by infiltration of rain fall into to the soil and it cause reduction of shear strength of soil. From observation in the field the rain-fall water get out at the plat-form of Pier P-1 structure area. Based on that conditions and the topography existing was proposed a new slope built in four steps with 1,50 m berm width and the slope is made 1 V : 2 H. To analizys the slope stability use Plaxis program version 8.50. The parameters of soil is presented in Table 2. below.

Based on the situation and the condition in the field, the designer gave instruction to instale Inclinator instrument to mesure the soil mouvement. A new slope should be built in this place to prevent the landslide and ensuit this structure to give a guarantee construction of bored piles foundation. he success of foundation construction on clay shale relies on proper planning, design, construction control and site supervision. The construction methods employed at site also have significant effect to ensure the successfully.

The geotechnic review is important for a civil engineering consultant, consultant supervisi and contractor to have some fundamental geotechnical knowledge to prevent failure occurs. To prevent the slope failure, a new slope should be built in four steps with 1,50 m berm width and the slope is made 1 V : 2 H is recommended. This new slope structure can ultimately facilitate the work in the field

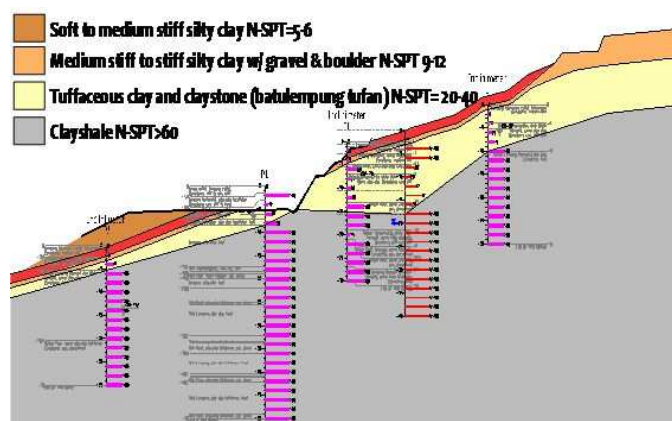
Figure 3: Subsoil Profile of the Site

Soil investigation has realized specially at slope failure location and around Pier P-1 Sta 22 + 625. The objective is to get a information about soil layers, condition and characteristics of subsoil, soil type and water level. The Figure 3 shows a schematic profile of sub-soil and Table 1 presents the result of laboratory tests of the soil properties.

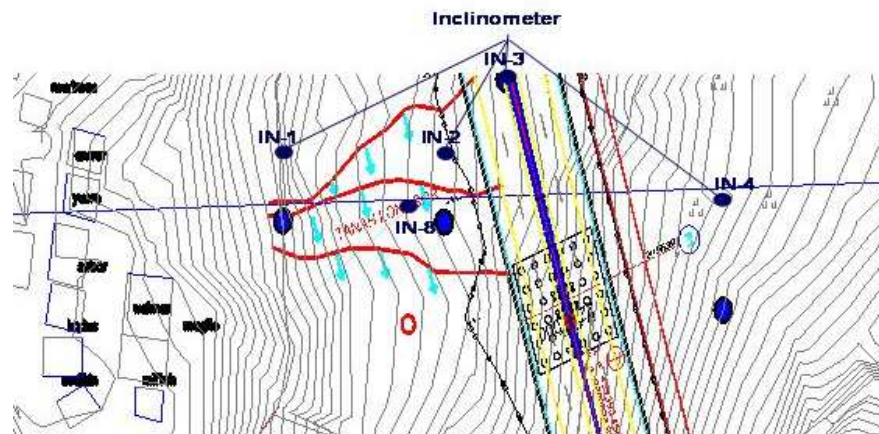
Figure 4: Layout of the Inclinator at Pier-P1 Sta. 22+625

To indikuate a movement of soil in around of the slope location and location of the Pier-P1 structure, was installed several inclinometers to measure the landslide or soil lateral mouvement. The observation with the inclinometers take time more than 30 days and 25 m depth from the surface land existing. Layout of the Inclinator is presented in Figure 3 below.

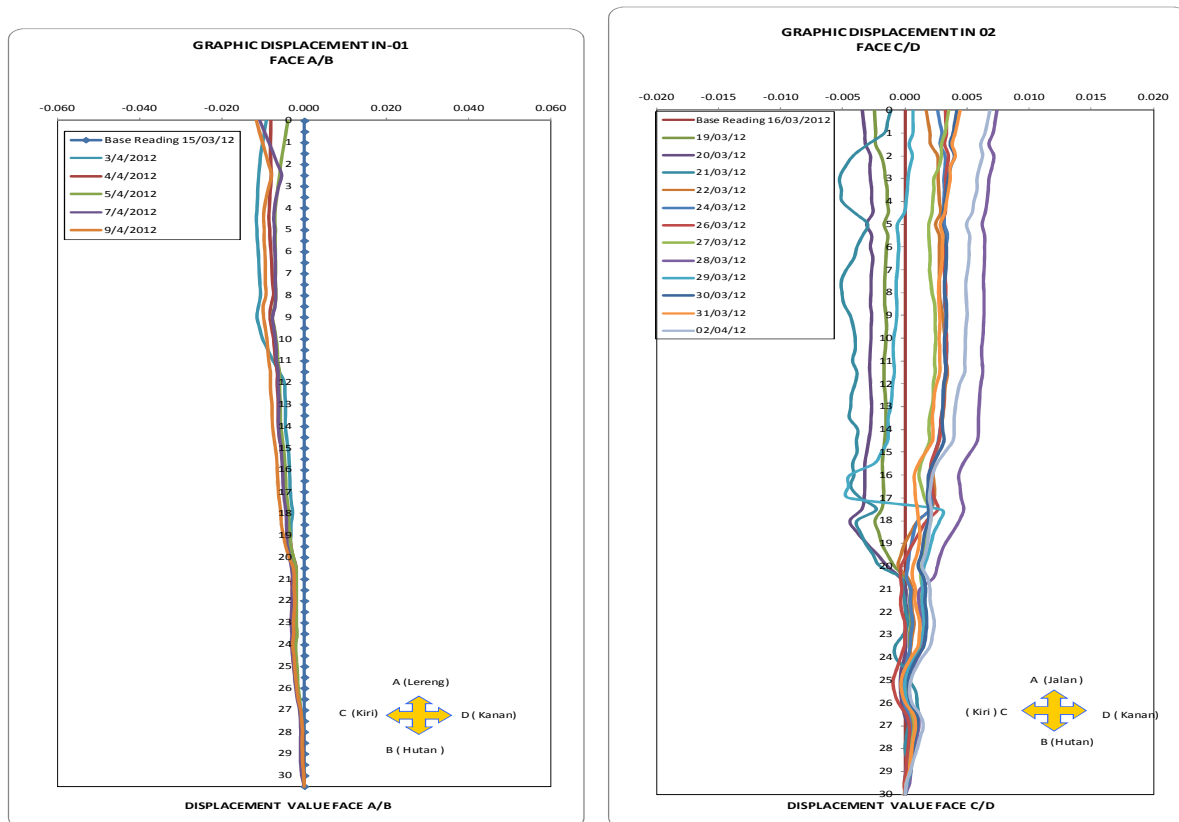
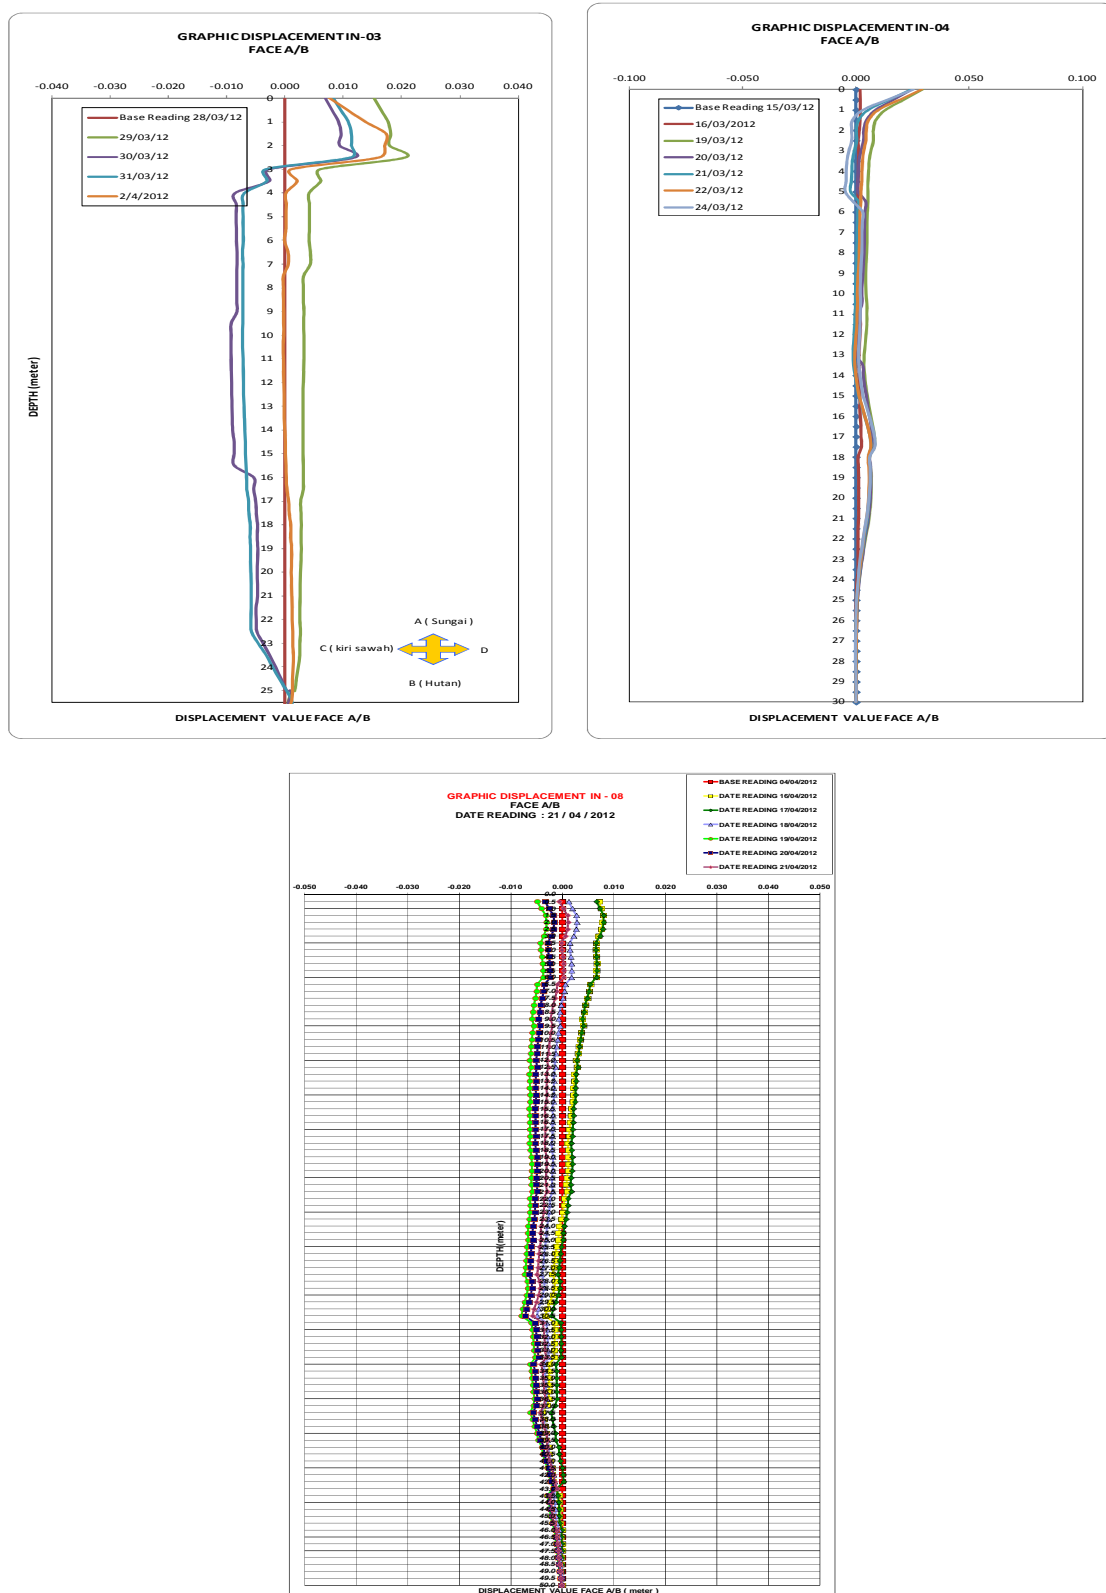
Figure 5: Results of Mesurement Inclinometers at Sta. 22+625

Figure 5 shows the results of several tools inclinometer measurement. Inclinometer number 01 indicate that there are soil movemnt from the surface land untill 28 m depth from the top surface. The value of the soil movemnt is about from 10 cm to 15 cm. Inclinometer no.02 shows the movemnt of the soil in two directions ranges from 5 – 10 cm

from the land surface to 25 m depth. Inclinator no.3 shows the soil movement in two directions with ranges 20 cm from top surface to 5 m depth and the soil movement change direction to 10-12 cm till the end of the Inclinator. Inclinator no.04 address the movement of soil vers 1m at the top of surface and return to value of 0-5 cm displacement untill the 30 m depth. Inclinator no. 08 shows the soil movement from the top vers 10 cm and decline automatically at the end. In general, the measurement of all Inclinator shows a soil maximum movement at the top surface land and tends decline untill the end of the Inclinator. Beside that, in the field, there are differences elevation approximately 25 m between the original surface land (before slipe failure happen) and after slipe failure happened.This prouves that the slip failure happened is caused by reduced shear strength of the soil significantly.

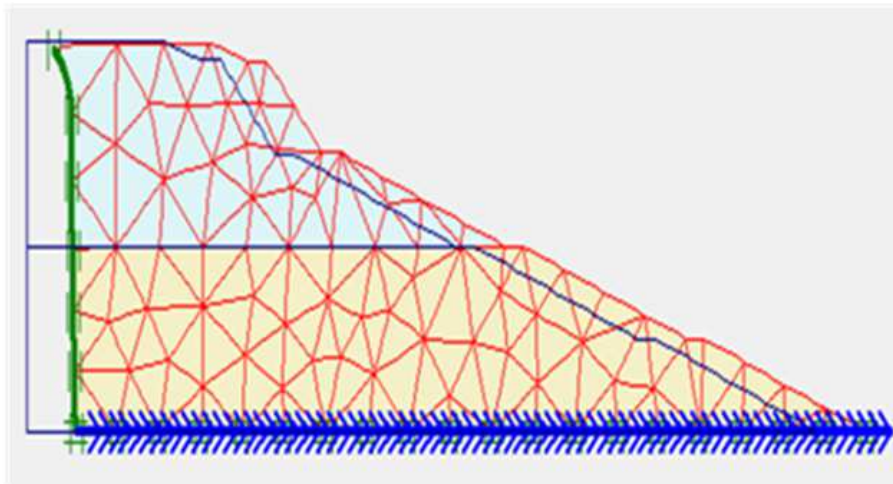
Figure 7: Deformed Mesh

The result of the Plaxis program shows the deformed mesh in Figure 7. The Figure 8 shows total displacements $543,78.10^{-3}$ m and the direction of soil displacements is showed in Figure 9, Maximum potential of slope failure is presented in Figure 10 and the Effective stress is $-454,86 \text{ kN/m}^2$ presented in Figure 11. Finally, the Figure 12 shows the safety factor obtained. The safety factor is 2,60 more than 1,30 recommended in the field, so the slope is stable. From the slope stability analysis used Plaxis version 8.50 got a good solution to prevent slope failure with a new slope built in four steps with 1,50 m berm width and the slope is made 1 V : 2 H.
